# CONSTRUCTION AND MAINTENANCE OF THE TREBIZOND-IRAN TRANSIT ROAD

By W. Cramer, A.M.I.Struct.E.

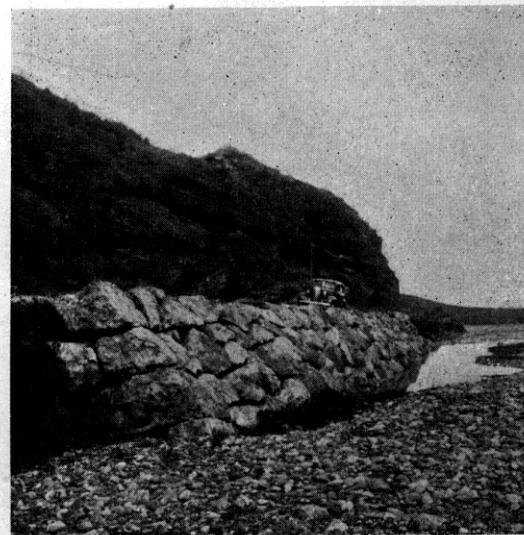
(b) *Rock Block Protection.* Fig. 8 shows a typical cross section of the rock block protection adopted. Giving the work a definite section was found to give better results than just throwing in the blocks and allowing them to settle at will. It was specified that where possible the volume of each individual block forming the face in contact with the water was not to be less than 0.75 m.cub. (26.5 cubic feet). The extreme limit for the remaining blocks was 0.40 m.cub. (14.1 cubic feet). The whole of this work was accomplished without the aid of machinery. The blocks forming the face were placed with their lengths at right angles to the face and sloping backwards. The sloping back was used for the sake of economy. Foundation depth was from 1 (39 inches) to 1.50 metres (59 inches), the latter seldom being exceeded (Fig. 11).

Fig. 11. Rock Block Protection.

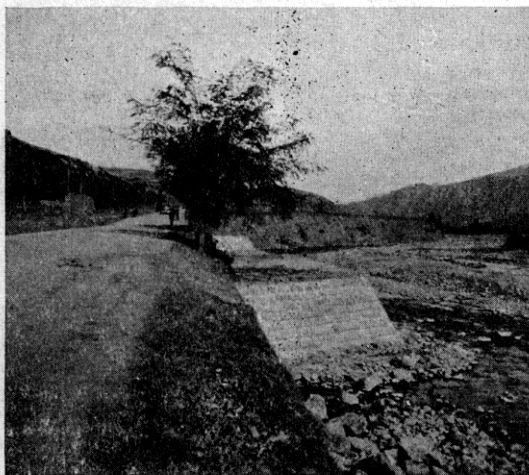
(c) *Weirs.* Figs. 9 and 10 show a non-submersible and a submersible directional weir respectively. The non-submersible type acts by intercepting the main current of water and forcing it to change its direction, thus protecting a portion of the bank behind it. The submersible type (Fig. 13) points upstream and by allowing the current to pass over it deflects it at right angles to itself and therefore

Fig. 13. Submersible Weirs Protecting Old Wall.

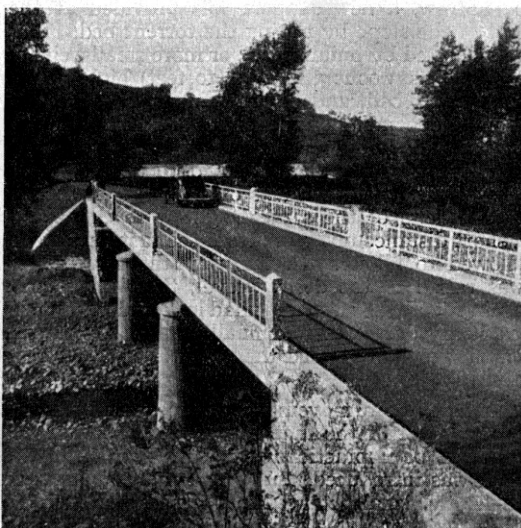
(See Figs. 15, 16, 17, 18 and 19).

Fig. 19. Typical Concrete Bridge.

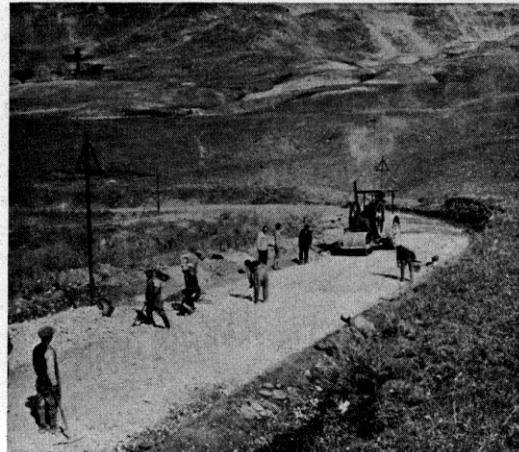
The least width of road formation is 7 m. (23 feet), of which only 5 m. (16.4 feet) is being metalled. Unfortunately the very important factor of consolidation of earth fills could not be dealt with thoroughly owing to lack of appropriate machinery. Tamping was done by hand and wherever possible fills were allowed a year to settle before rolling was undertaken (Fig. 20).

Fig. 20. Rolling on the Kóp Pass.

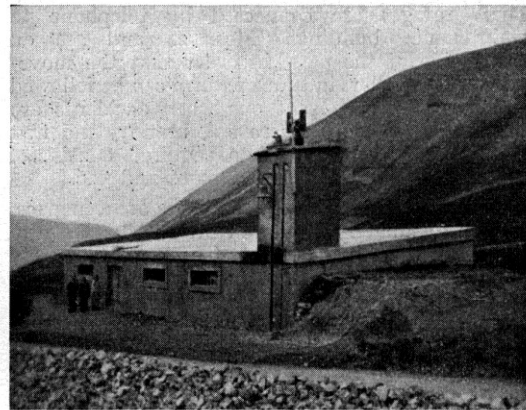
Fig. 21. Refuge on the Kóp Pass.

Fig. 22. Refuge on the Zigana Pass.

believed. Refuges have now been built at dangerous points (Figs 21 and 22), and posts painted black, and placed at short intervals along the road, guide the traveller through the blinding hurricane. These refuges are connected by telephone to maintenance buildings (Figs. 24 and 25) on either side of the pass, in order that the movements of travellers in time of storm can be followed and search parties sent out when accidents are suspected. Refuges where tea, brandy, and first aid are provided free when required consist of two large rooms, a stable, a store and w.c.

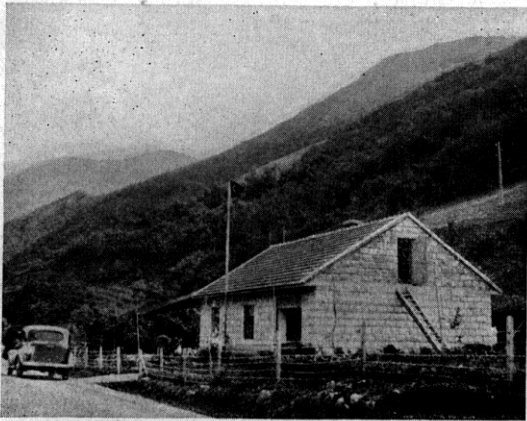
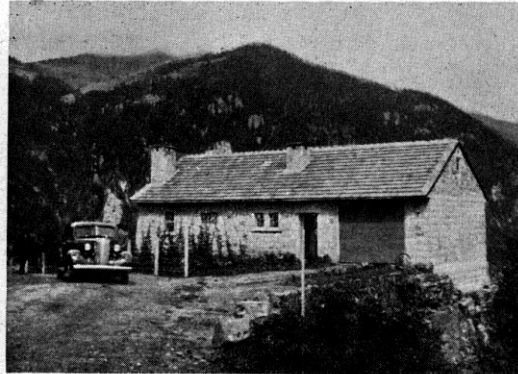
Fig. 24. Maintenance Building.

Fig. 25. Maintenance Building.

The men are normally housed in maintenance buildings built at 20 kilometre (12.5 miles) intervals along the road. These buildings include rooms, kitchens and sanitary accommodation for both men and engineers. A garage is also part of the standard equipment of these buildings.

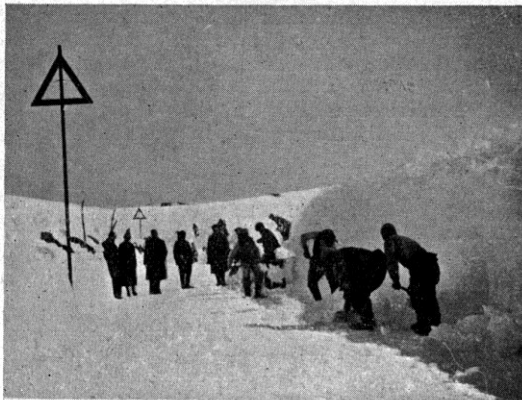
Fig. 27. Keeping the Road Open.

too exaggerated; their faces seared and blackened by the cold and lashing snow they carry on the task of keeping the road open throughout the winter with an indestructible good humour which pulls them through. (Fig. 27.) Two snow ploughs, fixed to 3-ton lorries, assist in the lower lying sections.

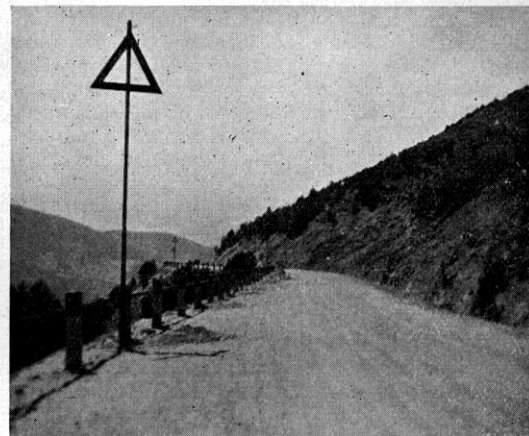
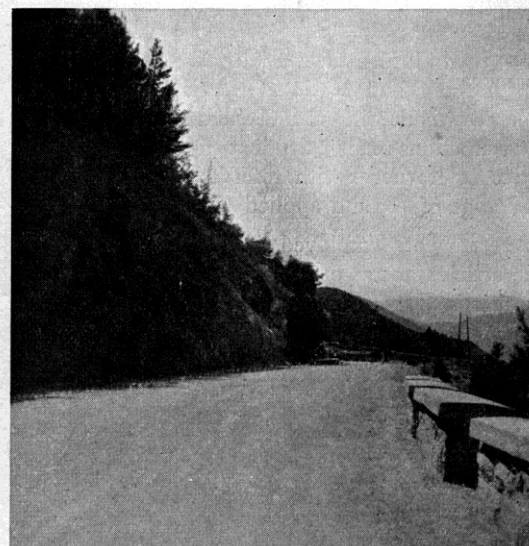
Fig. 29. Southern Slope of the Zigana Pass.

Figs. 28, 29, and 30 show sections of the completed road.
