CONSTRUCTION AND MAINTENANCE OF THE TREBIZOND-IRAN TRANSIT ROAD

By W. Cramer, A.M.I.Struct.E.

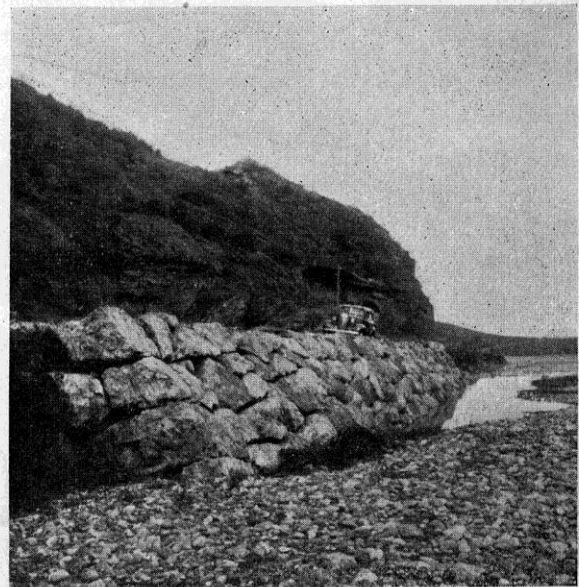
(b) *Rock Block Protection.* Fig. 8 shows a typical cross section of the rock block protection adopted. Giving the work a definite section was found to give better results than just throwing in the blocks and allowing them to settle at will. It was specified that where possible the volume of each individual block forming the face in contact with the water was not to be less than 0.75 m.cub. (26.5 cubic feet). The extreme limit for the remaining blocks was 0.40 m.cub. (14.1 cubic feet). The whole of this work was accomplished without the aid of machinery. The blocks forming the face were placed with their lengths at right angles to the face and sloping backwards. The sloping back was used for the sake of economy. Foundation depth was from 1 (39 inches) to 1.50 metres (59 inches), the latter seldom being exceeded (Fig. 11).

Fig. 11. Rock Block Protection.

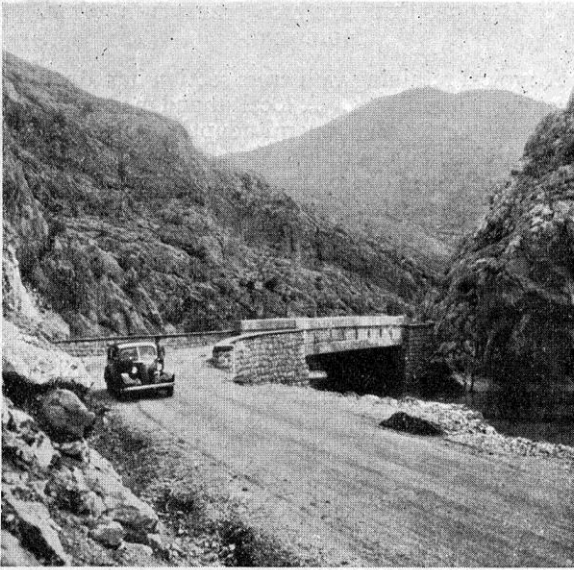
Fig. 15. Gorge of the Harshit.

Fig. 16. Plain Concrete Arch Viaduct.

Fig. 17. Reinforced Concrete Bridge.

Fig. 18. New Deck on Old Piers.

- bridge of 19 m. (62 feet) clear span. Free end on R.C. rockers, masonry abutments on concrete foundations and timber piles.
- (d) Plain concrete semi-circular arch viaduct at 153rd kilometre. Clear span 20 m. (65 feet) on rock foundations.
 - (e) Reinforced concrete beam bridge at 177th kilometre. Two freely supported spans of 10 m. (33 feet) each. Masonry abutments and piers on concrete foundations and timber piles.
 - (f) Old timber decked bridge over River Choroh at 197th kilometre, repaired and modernised. Old piers repaired and redecked with reinforced concrete. Total span 33 m. (108 feet).
 - (g) Plain concrete arch bridge over River Choroh at 217th kilometre. Clear span 15 m. (50 feet) on rock foundations.
- (See Figs. 15, 16, 17, 18 and 19).

Fig. 19. Typical Concrete Bridge.

- (a) Reinforced concrete viaduct at 100th kilometre. Three continuous spans of 9 m. (29.5 feet) and overhang, on columns founded on rock.
- (b) Old packhorse track bridge repaired and modernised at 106th kilometre. Total span 138 m. (453 feet). Six new spans added and old bridge levelled and widened with reinforced concrete.
- (c) Reinforced concrete through bridge over the River Harshit at 108th kilometre. Beam

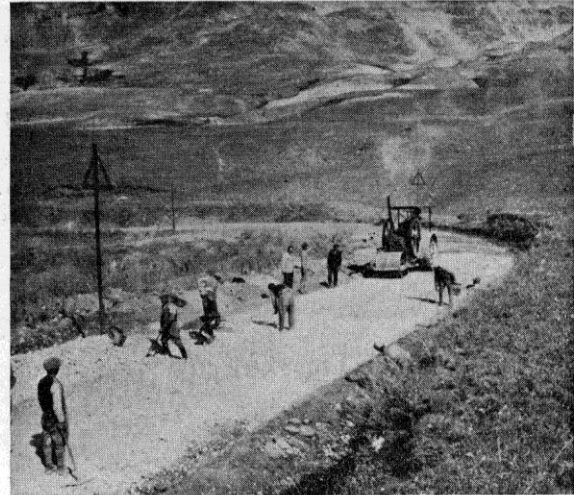
The least width of road formation is 7 m. (23 feet), of which only 5 m. (16.4 feet) is being metalled. Unfortunately the very important factor of consolidation of earth fills could not be dealt with thoroughly owing to lack of appropriate machinery. Tamping was done by hand and wherever possible fills were allowed a year to settle before rolling was undertaken (Fig. 20).

Fig. 20. Rolling on the Kop Pass.

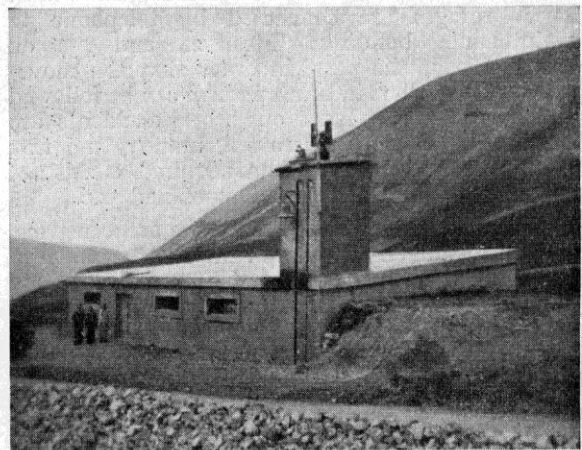
Fig. 21. Refuge on the Kop Pass.

Fig. 22. Refuge on the Zigana Pass.

believed. Refuges have now been built at dangerous points (Figs 21 and 22), and posts painted black, and placed at short intervals along the road, guide the traveller through the blinding hurricane. These refuges are connected by telephone to maintenance buildings (Figs. 24 and 25) on either side of the pass, in order that the movements of travellers in time of storm can be followed and search parties sent out when accidents are suspected. Refuges where tea, brandy, and first aid are provided free when required consist of two large rooms, a stable, a store and w.c.

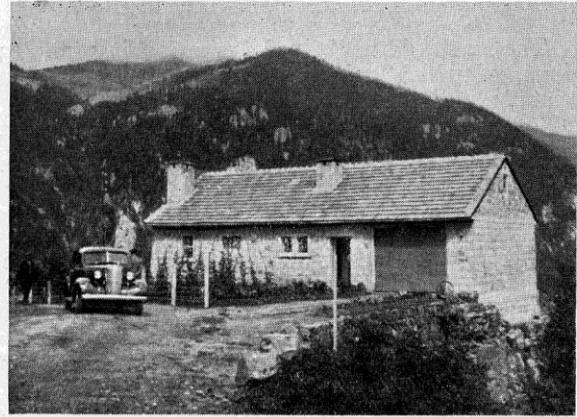
Fig. 24. Maintenance Building.

Fig. 25. Maintenance Building.

The men are normally housed in maintenance buildings built at 20 kilometre (12.5 miles) intervals along the road. These buildings include rooms, kitchens and sanitary accommodation for both men and engineers. A garage is also part of the standard equipment of these buildings.

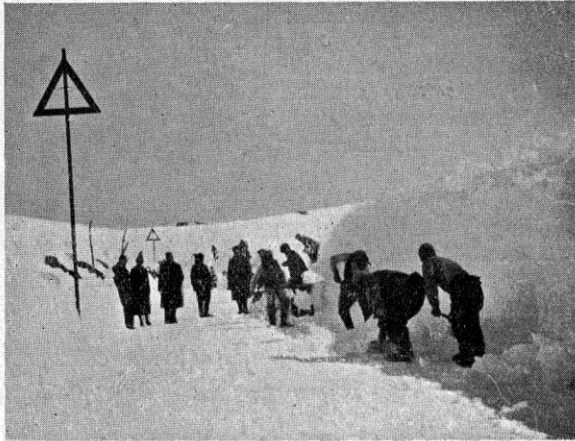
Fig. 27. Keeping the Road Open.

too exaggerated; their faces seared and blackened by the cold and lashing snow they carry on the task of keeping the road open throughout the winter with an indestructible good humour which pulls them through. (Fig. 27.) Two snow ploughs, fixed to 3-ton lorries, assist in the lower lying sections.

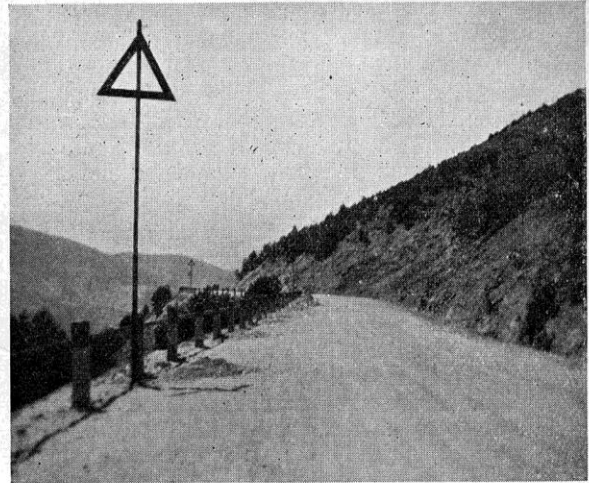
Fig. 29. Southern Slope of the Zigana Pass.

Figs. 28, 29, and 30 show sections of the completed road.
